Report No. UT-19.17

PERFORMANCE EVALUATION OF TYPICAL UDOT SURFACE TREATMENTS

Utah Department of Transportation
Research & Innovation Division

**Final Report
July 2019**

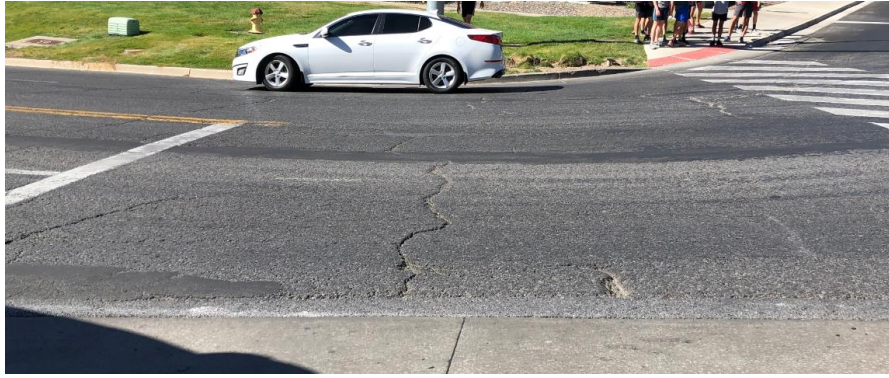
Transverse cracking is also known as low-temperature cracking. It is caused by the shrinkage of the mixture due to temperature changes. This kind of crack is recorded as the count number of transverse cracks on the section at each severity level. Figure 2-2 shows an example of the typical transverse crack. The transverse crack Maximum Allowable Extent (MAE) for low severity is one for every ten feet, or 53 cracks for a 528-foot sample section is 100%. Medium severity is 75%, and high severity is 50%.

Figure 2-2. Transverse Crack

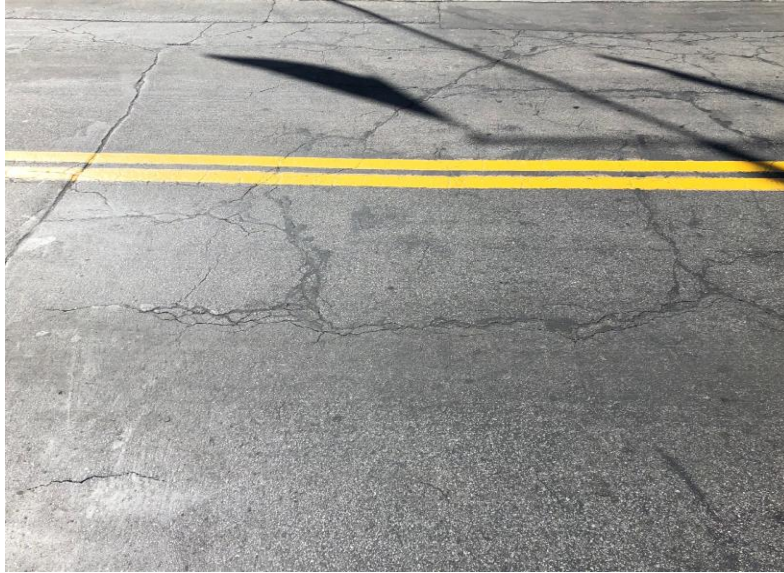
Block cracking is the pattern of cracks that divides the pavement into approximately rectangular pieces, with sizes ranging between 0.1 and 10 m^2 (Federal Highway Administration). The maximum allowable extent of the block crack for a 528-foot sample section at low severity is 528 feet in total, at the medium severity level it is 75%, and high severity is 50%. Figure 2-3 shows an example of block cracks.

Figure 2-3. Block Crack

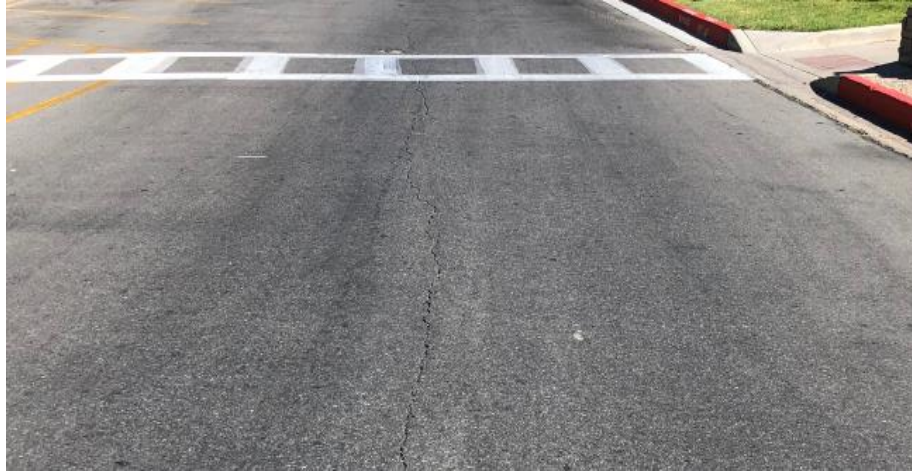
Cracks predominantly parallel to the pavement centerline and located within the lane but not on the wheel path are classified as Longitudinal Non-Wheel-Path (LNWP) cracking while longitudinal cracking in the wheel-path area is considered as Wheel-Path (WP) cracking. The LNWP crack is recorded as the length with sealant in good condition at each severity level. The MAE for low severity LNWP is 528 feet of one 528-foot sample section, which is 100% of the

Figure 2-4. Longitudinal Crack

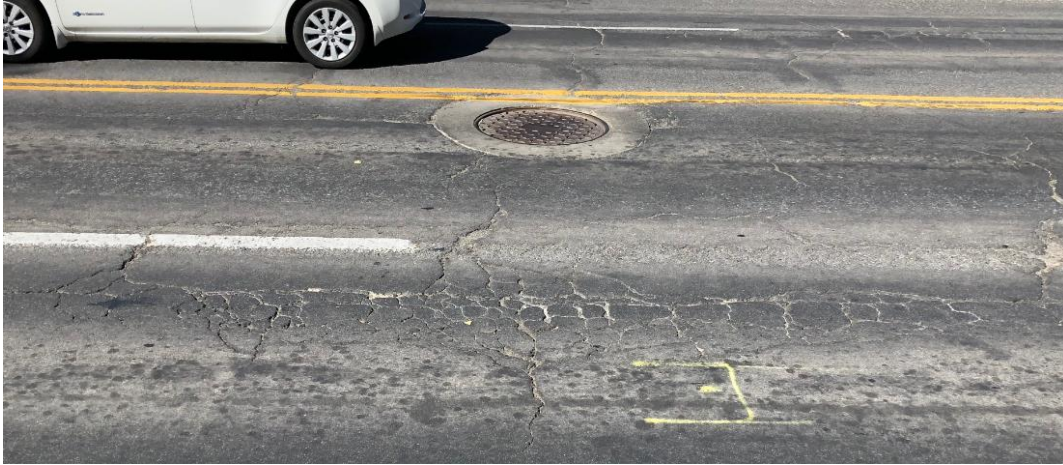
Low-severity WP cracks are longitudinal cracks in the wheel path with few secondary cracks. Medium severity has interconnected cracks resembling an alligator's back. High severity is interconnected cracks with moderate- to high-severity spalling between them. WP cracking is primarily considered load related (Miller and Bellinger 2014; UDOT 2009A). Also, the normal longitudinal crack on the wheel path is counted as Low-Level WP cracking. A picture of this type of distress is shown on figure 2-5.

Figure 2-5. Wheel-Path Crack

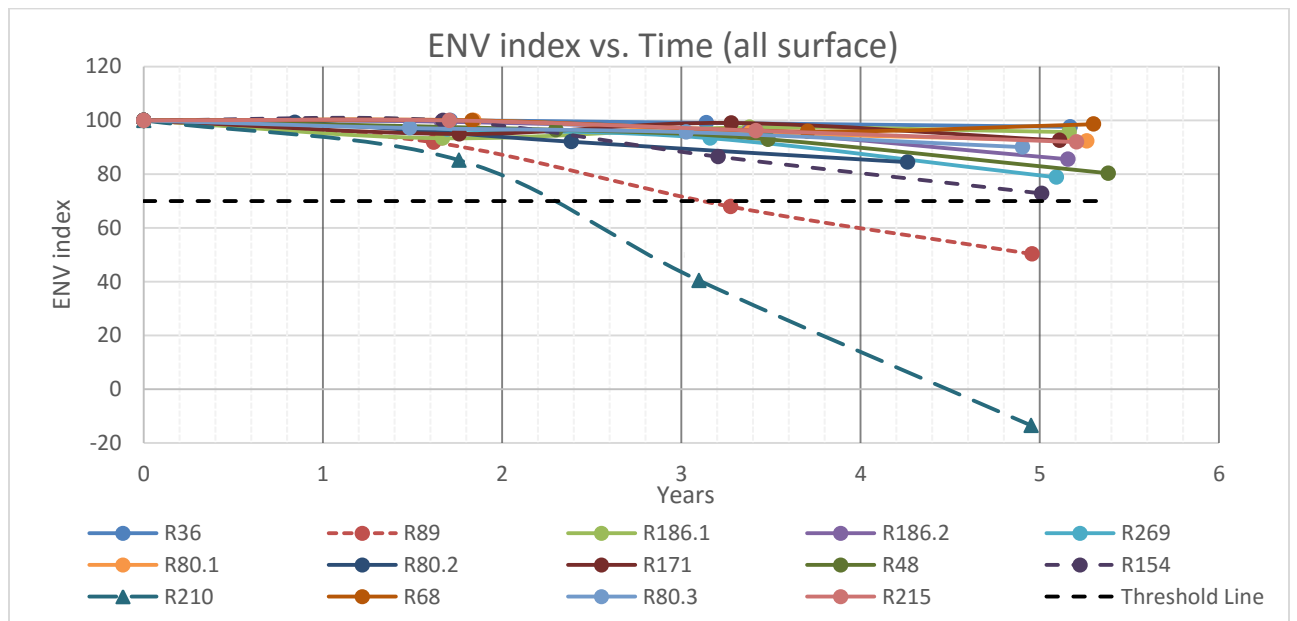
Figure 5-1 ENV Index Summary Plot

The ENV index summary plot shows the expected decreasing trend at an increasing rate for most TLT sections. SR-210 and SR-89 failed at year two and three, respectively. The remaining TLT surfaces have an estimated life that ranges from six to eleven years. Half of the TLT sections have more LNWP cracks in comparison to other distresses. This is a common problem due to the low density at the pavement surface joint. The other half of the TLT sections have significant transverse cracks caused by low-temperature environmental conditions. Most of the TLT surface treatments follow expected life predictions, with the exception of SR-210 and SR-89.

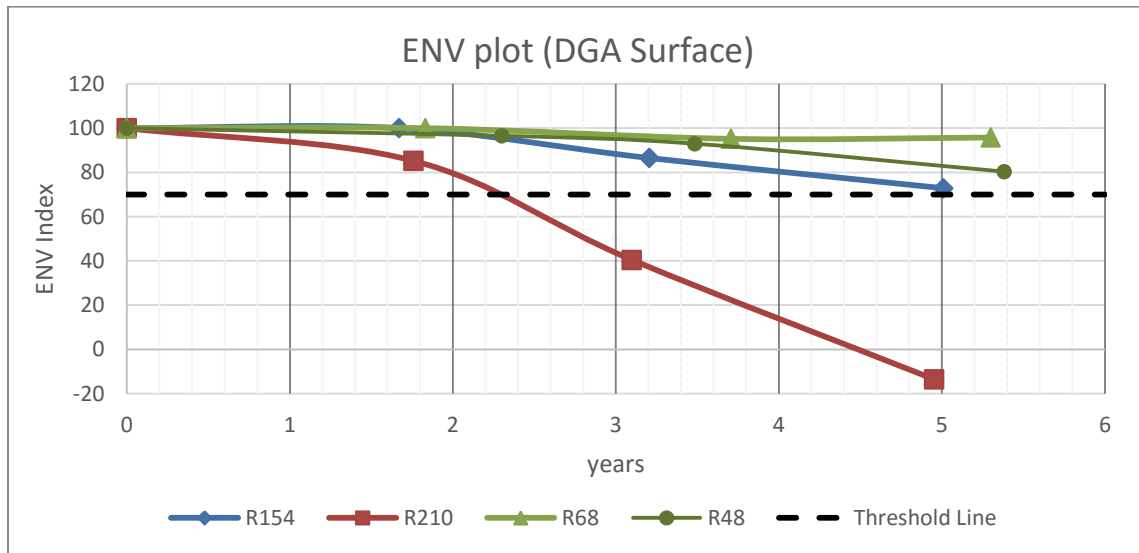
Figure 5-2. DGA TLTs ENV plot

In order to better understand the performance of each type of TLT, the data was separated into treatment type. Figure 5-2 shows the ENV index of the DGA surface only. SR-154, SR-68, and SR-48 have a fairly constant deterioration rate after two-and-a-half years, but SR-210 did not follow this pattern.

As was discussed in Section 4.3.3, SR-210 is the route going to Alta and Snowbird mountain resort, and it is subjected to harsh winter conditions. The average elevation of SR-210 is 8000 feet from sea level, which is 3800 feet higher than Salt Lake City. As shown in Table 5-1, this high elevation makes the average temperature of the SR-210 section about 10 degrees lower than the greater Salt Lake area (NOAA data) and the snowfall of the Alta area is ten times more than the Great Salt Lake area. This environment is believed to be a critical issue for the SR-210 TLT section as this environment led the surface to start rapidly deteriorating before 2015. As a result, this route has the worst performance score out of the 14 treatments evaluated. However, it

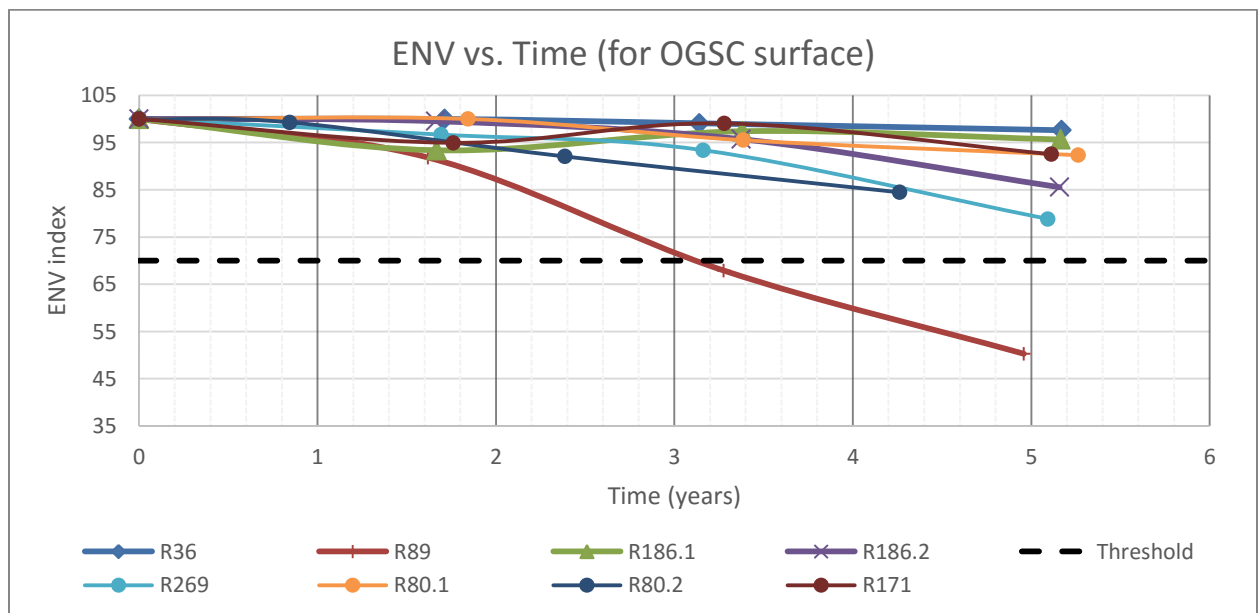
Figure 5-3. OGSC TLTs ENV Index Plot

The OGSC surface treatment made the biggest sample group in this study. The ENV index of all OGSCs is shown in Figure 5-3. Seven sections had reasonable decreasing trends, and only SR-89 stands out from the group. The estimated life ranges for OGSC surface treatment due to ENV condition were between 6 and 11 years, and the average is 7.2 years (SR-89 being the exception since it failed at 3.3 years).

After five years, the ENV index of the majority OGSC surface treatment ranges from 78 to 97 (SR-89 was out of range). As Figure 5-3 shows, the ENV index value of SR-171, SR-186, and I-80 increased moderately from 2014 to 2015. Physically, this is unlikely although “self-healing” of the asphalt pavement has been reported. Self-healing is still a challenging issue for pavement engineering. This complicated mechanism is not well understood and was not considered for this study, so “self-healing” will not be

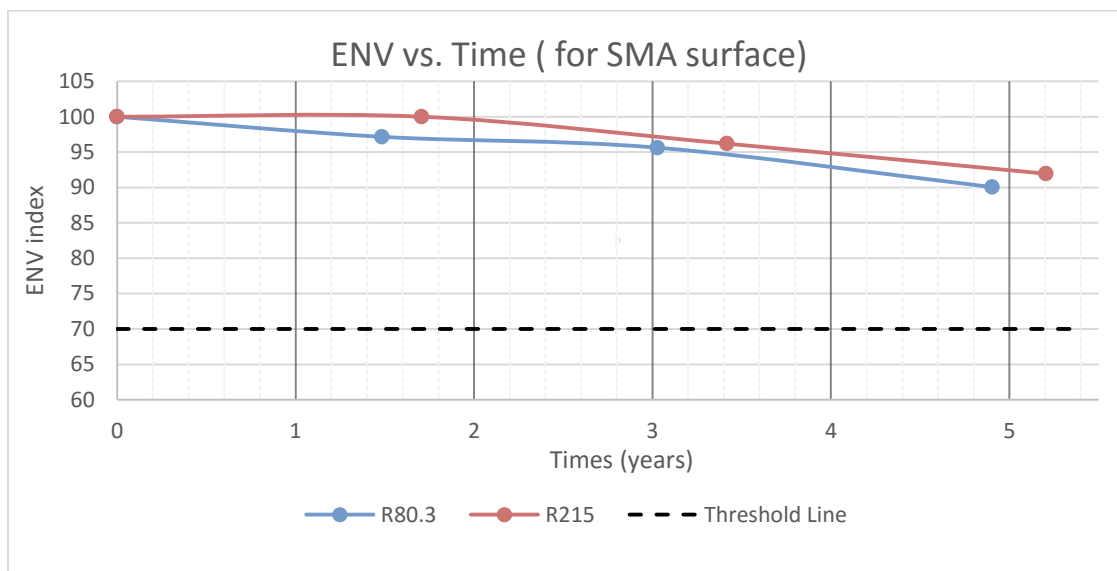
Figure 5-4. SMA TLTs ENV Plot

SMA treatments consist of only two sections, I-215 and I-80 section 3. As shown in Figure 5-4, both SMA sections have high ENV index. After five years, both sections still have a value above 90. The extended trend line shows the estimated lifetime for I-215 as 10 years and for I-80.3 as 11 years. On average, the life is estimated as 10 years for SMA surface treatment.

While only based on two surface sections, the SMA shows good performance. SMAs have better conditions than the other treatments. Since the deterioration rate of SMA is still not in the secondary stage, the life estimate is not reliable. Nevertheless, based on all the limitations cited, the estimated lifetime of SMA thin-lift treatment is shown in Table 5-4.

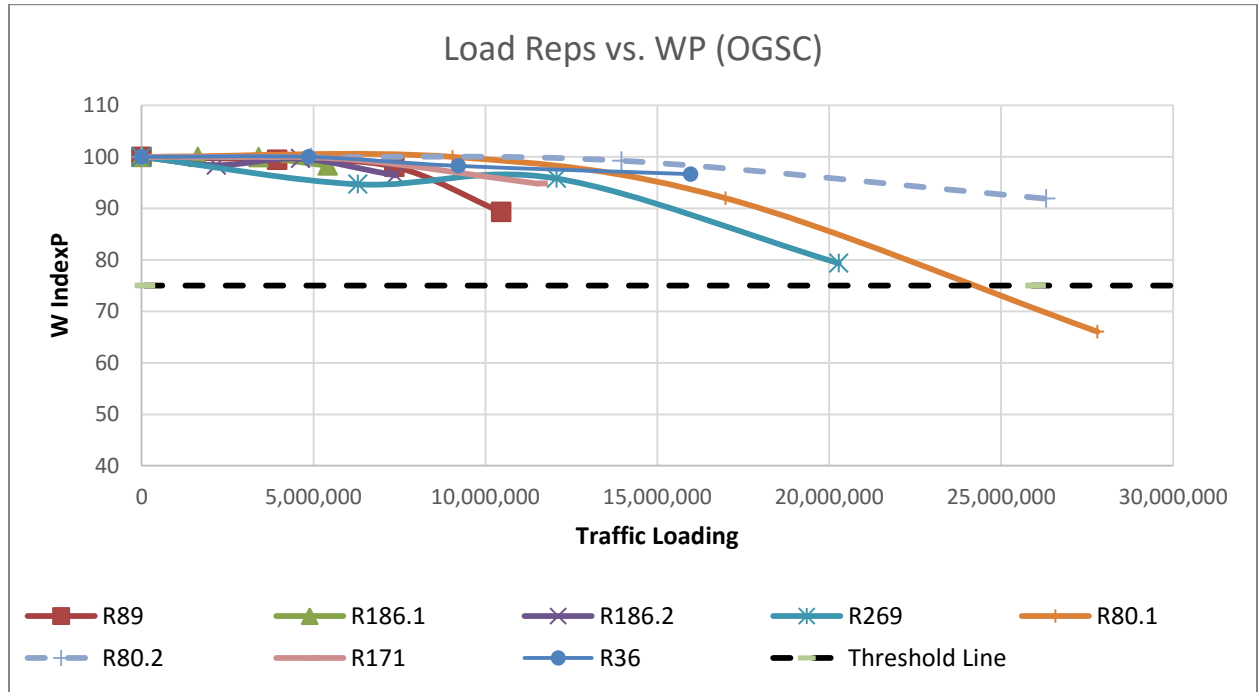
Figure 5-6. OGSC WP Index Plot

The Open-Graded Surface Course treatments consist of eight surface sections. The majority of OGSC surface treatments follow the general trend of decreasing performance at an increasing rate. Other studies have determined the life expectancy of an OGSC pavement under the designed condition to be between 8 and 12 years. Based on

the current daily traffic amount and growth rate, the estimated life for the OGSC surface treatment in Utah is about 8.5 years. Figure 5-6 shows this information.

The estimated lifetime for OGSC thin-lift treatments is shown in Table 5-5. By extending the data point line, the cross point of the threshold line and the trend line is the estimated lifetime, and the estimated traffic loading is calculated for all sections. The estimation of the life expectancy of the OGSC surface from the WP evaluation analysis is about 8.5 years on average. This value is lower than the ENV estimation result.

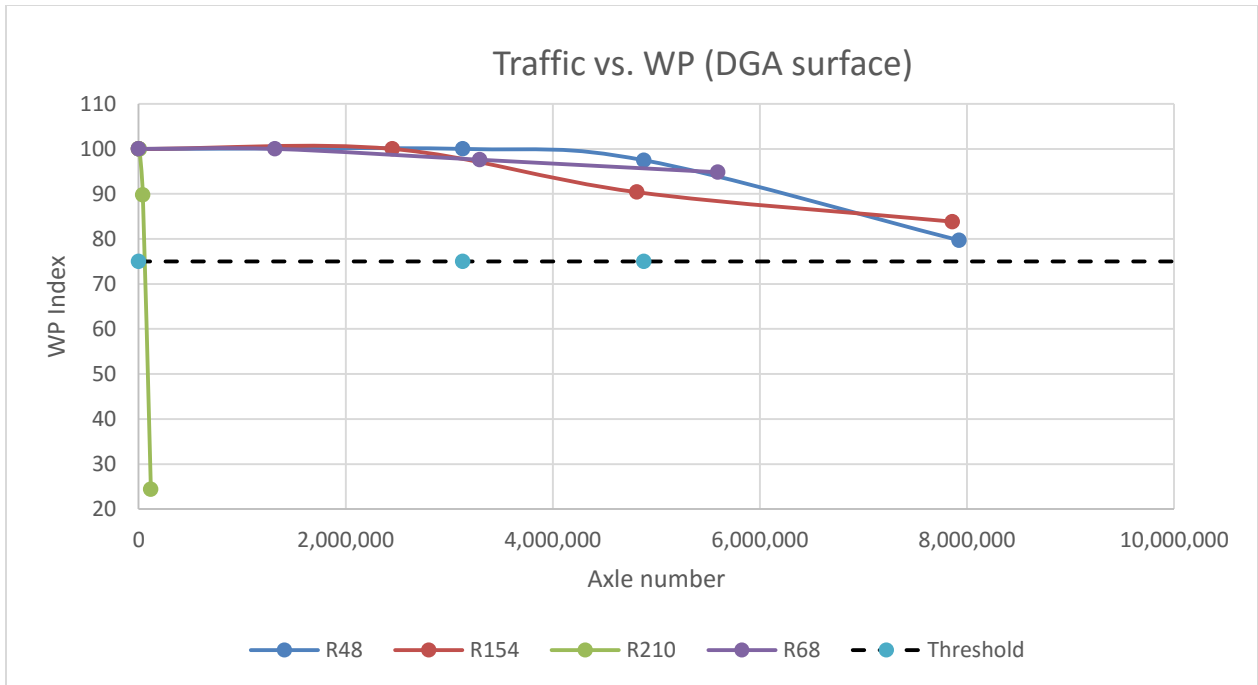
Figure 5-7. DGA WP Index Plot

The Dense Graded Asphalt surface treatment Wheel Path result shows that SR-154, SR-68 and SR-48 are still above the threshold value, and that SR-210 has failed. The value for the first three sections starts decreasing after 3 million load repetitions. SR-210 has the most special situation in the DGA study group as it has the most extreme environmental conditions out of all 14 sections. It is believed that the negative ENV score influenced the WP performance. This is shown in Figure 5-7.

The average failure point of DGA is about 8 million load repetition, which is about 8.5 years depending on the specific traffic (without SR-210). Table 5-6 shows the life predictions for DGA treatment.

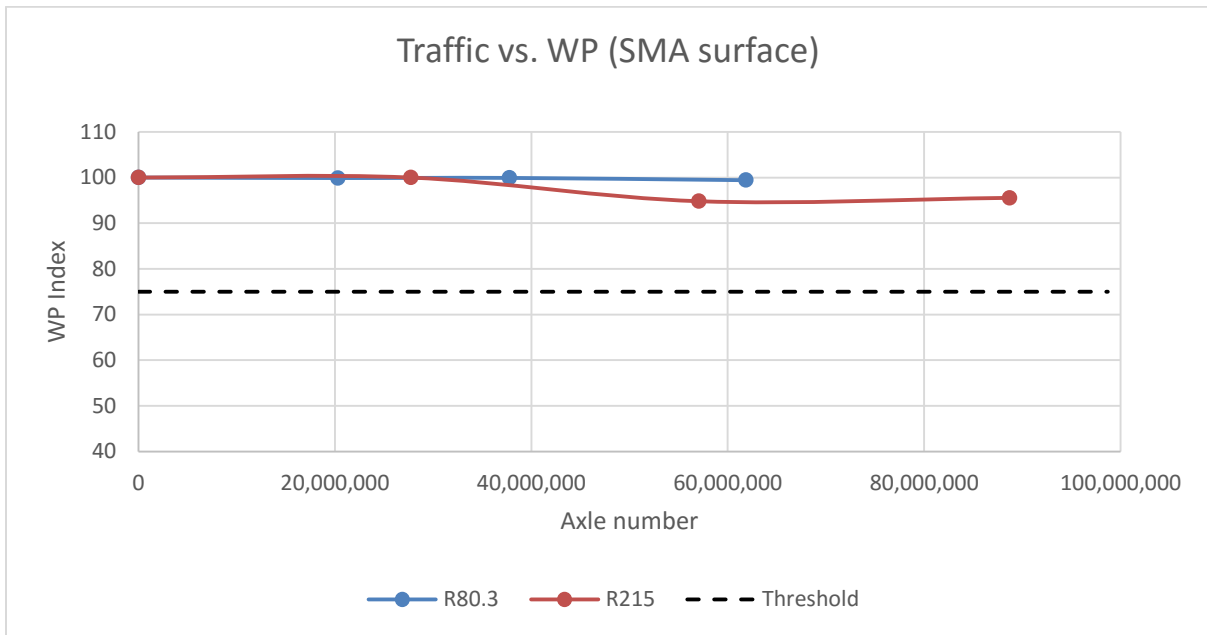
Figure 5-8. SMA WP Index Plot

The Stone Matrix Asphalt has the best performance among the three types of surface treatments studied. The plot shows the good quality of SMA on the Wheel-Path

index evaluation after five years of use. Even though there were only two routes that were resurfaced with the SMA treatment, the data, shown in Figure 5-8, shows the excellent performance results.

The SMA surface shows no WP index drop within the five years of this study. Both of the treated surfaces have the final WP index higher than 95, and no obvious decreasing trend or WP distress under such a high traffic volume. SR-215 has the highest traffic loading in all of 14 TLT sections (40 million load repetitions), but the wheel path shows no serious damage. SR-80.3 has the second highest traffic load repetitions and has a WP index of 99, the best performance evaluation on the Wheel-Path index. This results in a 13.5 years lifetime as shown in Table 5-7.
